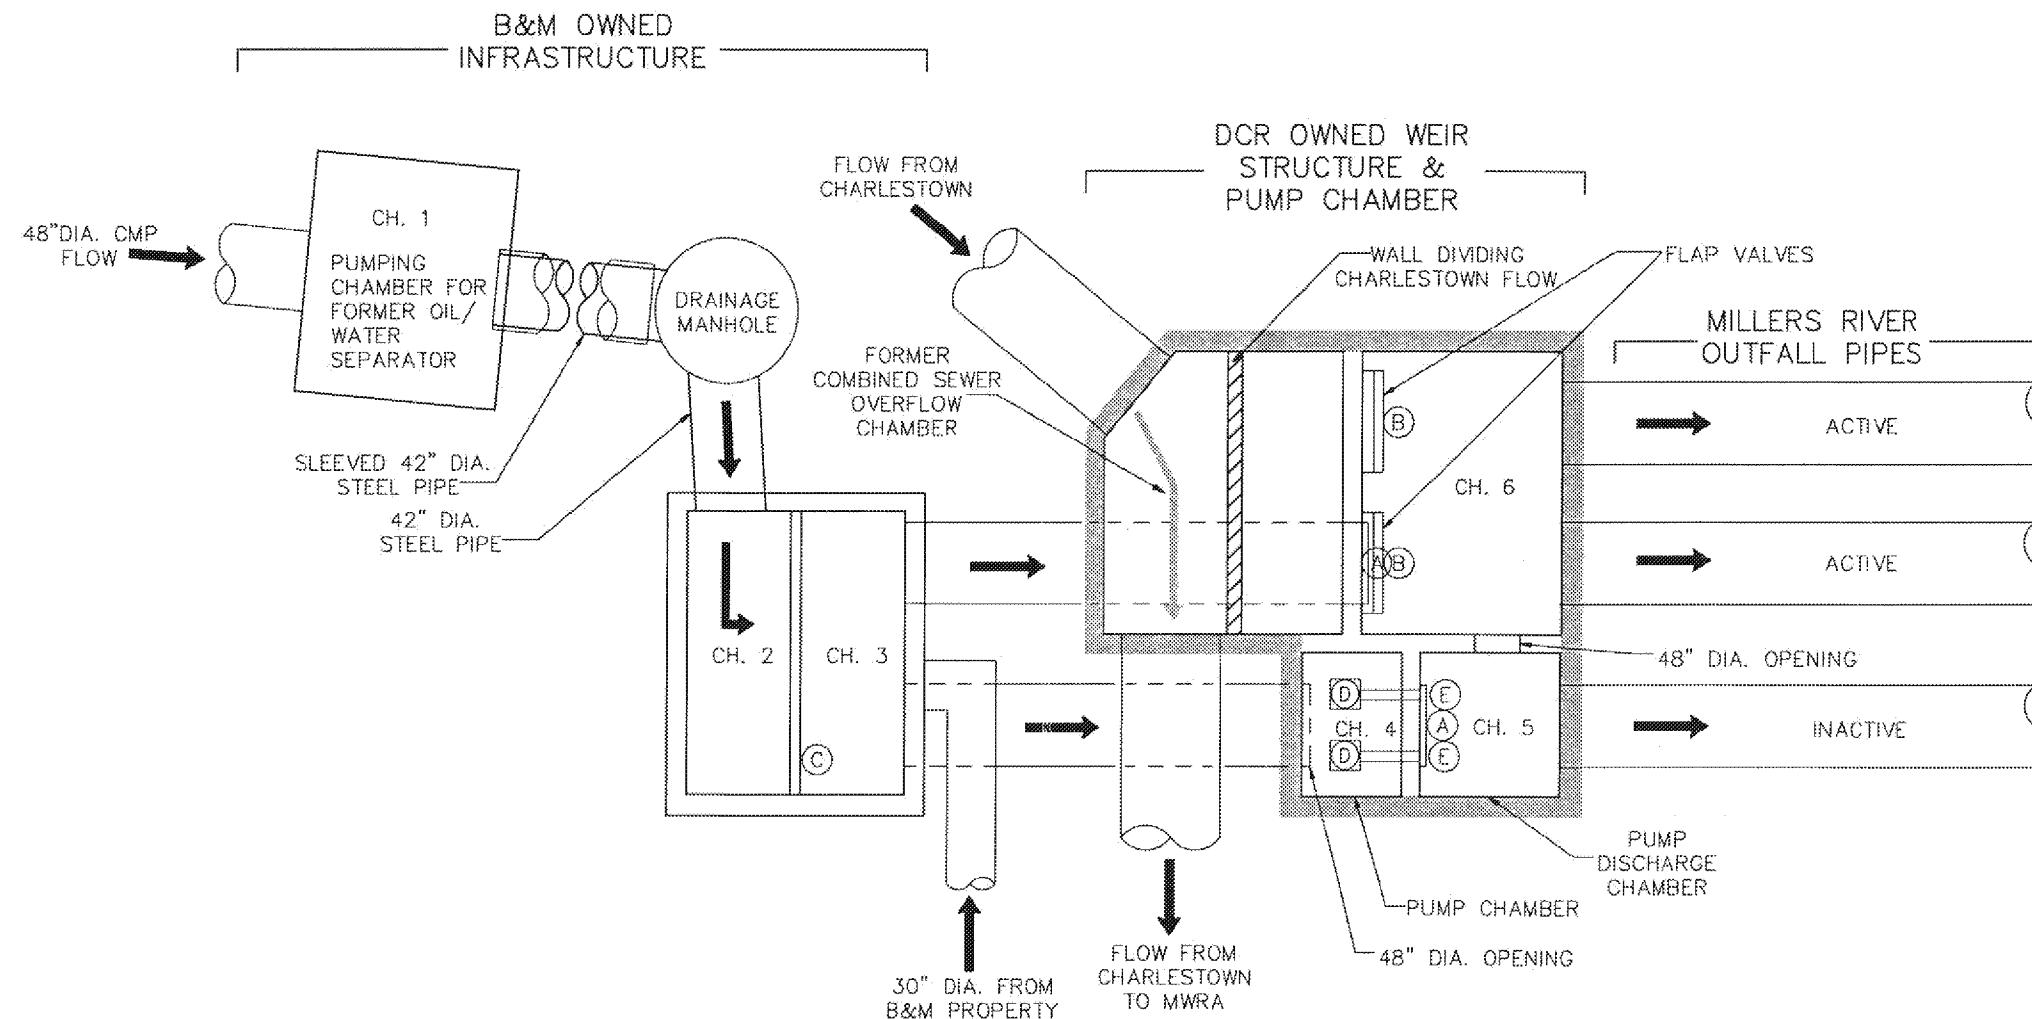
INFLUENT PIPE CONSISTS OF 48" DIA. CORRUGATED METAL. EFFLUENT PIPE CONSISTS OF 42" DIA. STEEL PIPE SLEEVED THROUGH EXISTING PIPE TO A CONCRETE MANHOLE STRUCTURE INSTALLED IN MAY 2010. BASE OF STRUCTURE OPEN TO THE ENVIRONMENT.

INFLUENT PIPE CONSISTS OF 42" DIA. STEEL PIPE ORIGINATING FROM CONCRETE MANHOLE, BOTH INSTALLED IN MAY 2010. WATER FLOWS OVER THE WOOD WEIR AND BENEATH THE HANGING BAFFLE. CONCRETE FLOOR INSTALLED AT BASE OF STRUCTURE IN MAY 2010.

WATER DISCHARGES TO CHAMBERS 4&6 BENEATH THE 66" CHARLESTOWN OVERFLOW CHAMBER AND PIPING THROUGH TWO 48" DIA. STEEL PIPES. CONCRETE FLOOR INSTALLED AT BASE OF STRUCTURE IN MAY 2010. INFLUENT PIPE FOR FLOW FROM B&M PROPERTY IS 30" DIA. CORRUGATED METAL.

THE ORIGINAL PUMPS IN CHAMBER 4 ARE INACTIVE. TWO SUBMERSIBLE PUMPS RATED AT 90 GPM PULL WATER FROM CHAMBER 4 AND DISCHARGE TO CHAMBER 5. WATER ALSO DISCHARGES THROUGH THE 48" CIRCULAR FLAP TO CHAMBER 5.

CHAMBERS 5&6 ARE HYDRAULICALLY CONNECTED BY A 48" DIAMETER OPENING AT THE BOTTOM OF CHAMBERS.

THE TWO 48" DIA. STEEL OUTFALL PIPES ORIGINATING IN CHAMBER 6 ARE FUNCTIONAL. THE 48" DIA. STEEL OUTFALL PIPE ORIGINATING IN CHAMBER 5 HAS BEEN DECOMMISSIONED SOMEWHERE BETWEEN CHAMBER 5 AND THE MILLERS RIVER; AND IS NOT CURRENTLY FUNCTIONAL.

60" FLAP VALVES HAVE BEEN SEALED SO THAT CHARLESTOWN FLOW DOES NOT DISCHARGE TO THE MILLERS RIVER. ADDITIONALLY, ORIGINAL WEIR IN OVERFLOW CHAMBER HAS BEEN EXTENDED TO CEILING OF THE CHAMBER CREATING A WALL, SO THAT CHARLESTOWN FLOW DOES NOT DISCHARGE TO MILLERS RIVER.

CHARLESTOWN FLOW CONTINUES TO THE MWRA PRISON POINT CSO FACILITY.
